# DEEP CREEK DAM

## PHASE I INSPECTION REPORT NATIONAL DAM INSPECTION PROGRAM

National Dam Inspection Program  
DEEP CREEK DAM, MONTGOMERY COUNTY, PENNSYLVANIA

(NDS I.D. <sup>Number</sup> PA 00200,  
DER I.D. <sup>Number</sup> 46-8), Delaware River

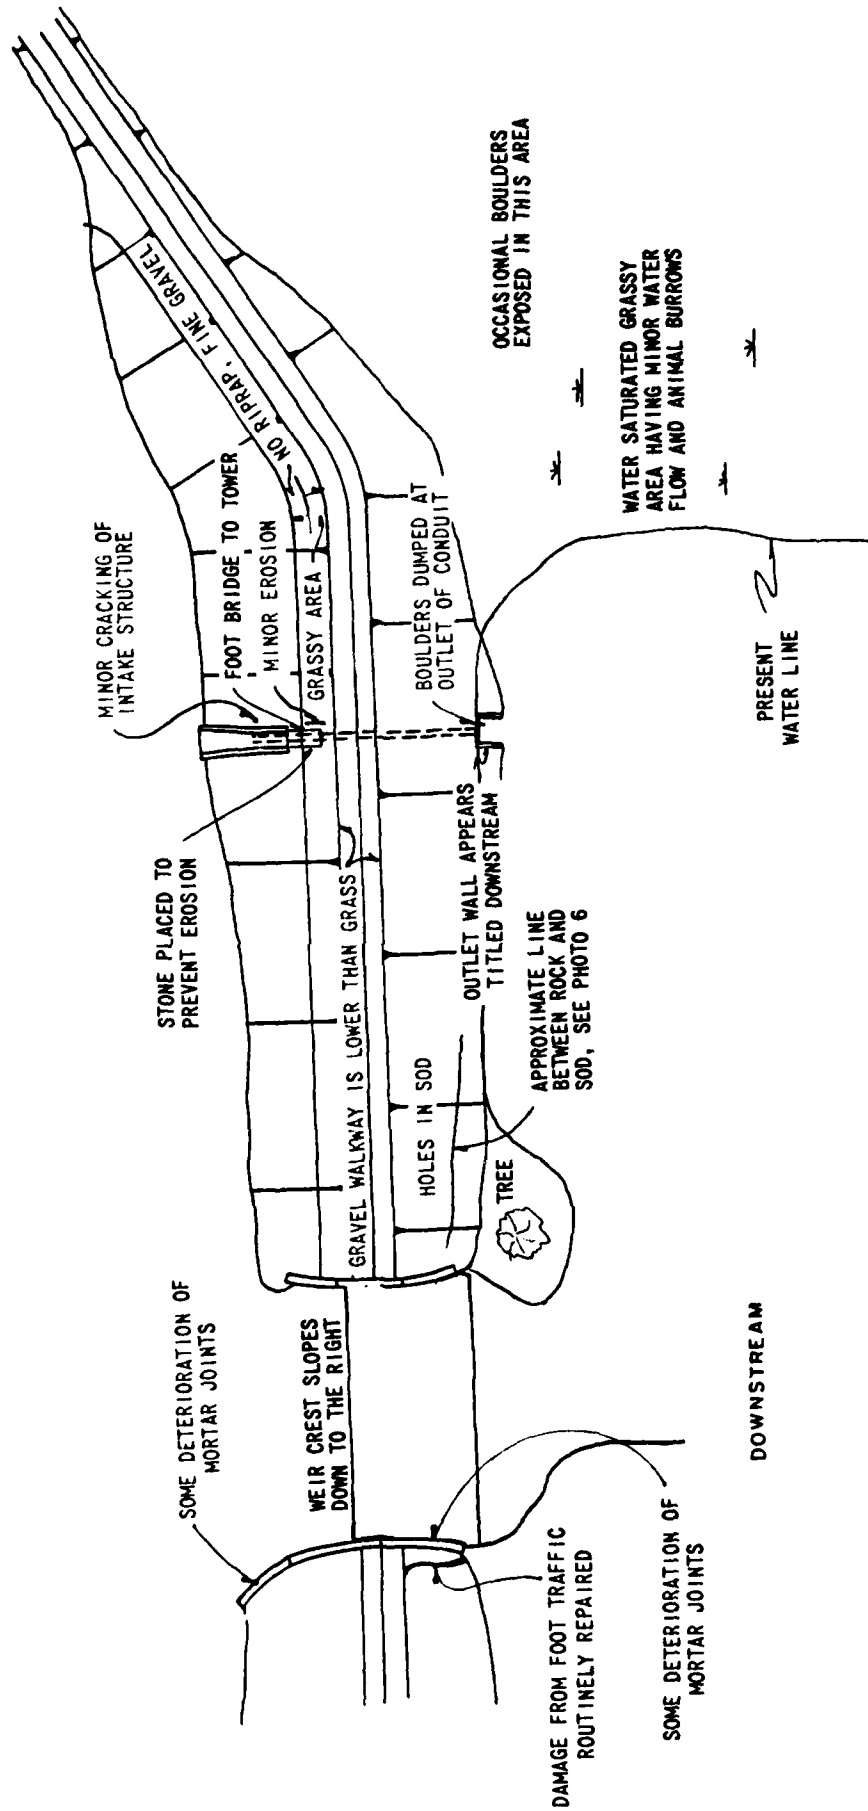
FIELD OBSERVATION PLAN  
DEEP CREEK DAM  
SHEET 5A OF 11

*Seepage noted at left downstream junction, see Sheet 5a of 11.*
